## Airbus A380 News – Update

### A380 Wing Rib Feet Cracks — Recent Developments

Page 2 of 2  
24 January 2012

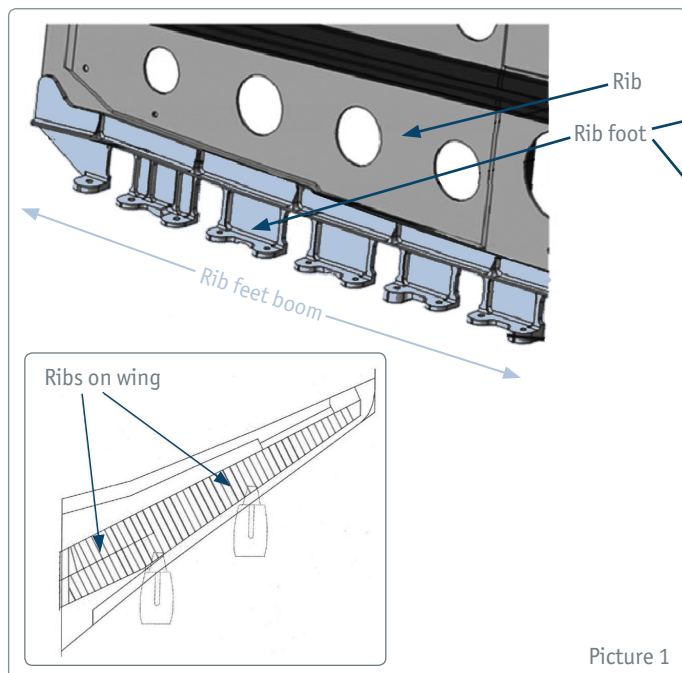
The AD identifies two different types of cracks on the rib feet (see picture 1), defined by Airbus as Type 1 cracks (connecting the rib feet holes) and Type 2 cracks in the vertical rib feet flange (horizontally). The rib feet connect the ribs to the inside skin of the wing. The wing ribs run perpendicular to the wing and provide for the stabilisation of the wing shape. Type 1 are cracks on the rib feet originating from the rib to skin panel attachment holes (see picture 2). Type 2 cracks are cracks in the vertical flange of the rib feet (see picture 3).

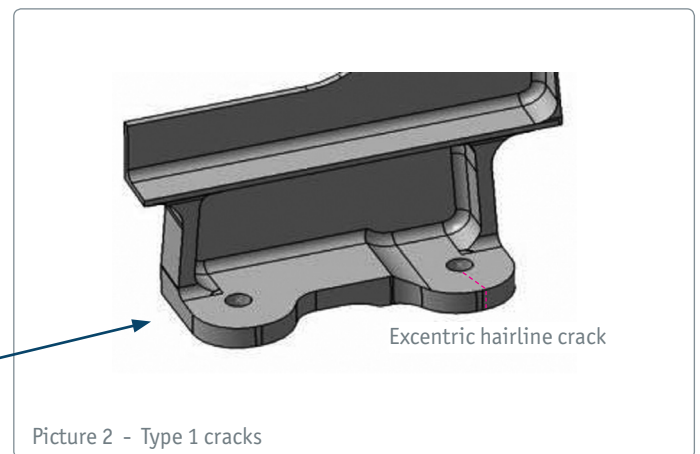
Airbus has identified that the Type 1 cracks were caused by a combination of high pre-stress, build stress and the particular aluminium alloy used to make some of the brackets (or wing rib feet) applicable to the production of the wings until recently.

For in-service aircraft, a program is already being worked out by Airbus that includes a permanent repair and long-term resolution of the issue with the Type 1 cracks. Replacement kits will be supplied and delivered by Airbus in accordance with the existing aircraft warranties.

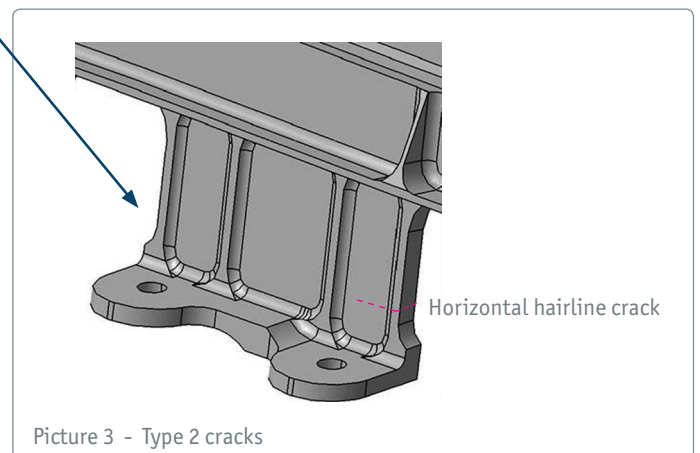
The actual root cause for Type 2 cracks is being investigated and Doric expects further results in the near future, taking into account the findings of the inspections ordered by the AD. Doric expects further ADs to be issued on this subject soon, setting out required inspection, repair and replacement procedures.

We expect Airbus to provide a similar solution in respect of Type 2 cracks, where required, once the AD inspection results have been analysed.

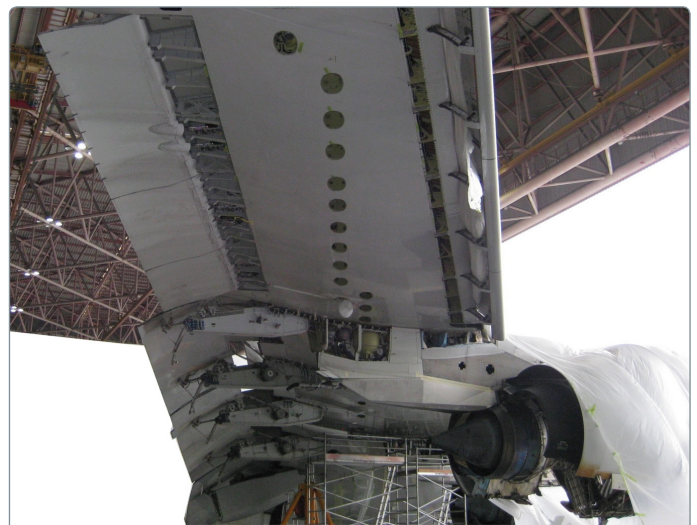
Picture 5 - A380 wing undergoing inspection
