## Airbus A380 News – Update

### A380 Wing Rib Feet Cracks — Recent Developments

Page 2 of 2  
24 January 2012

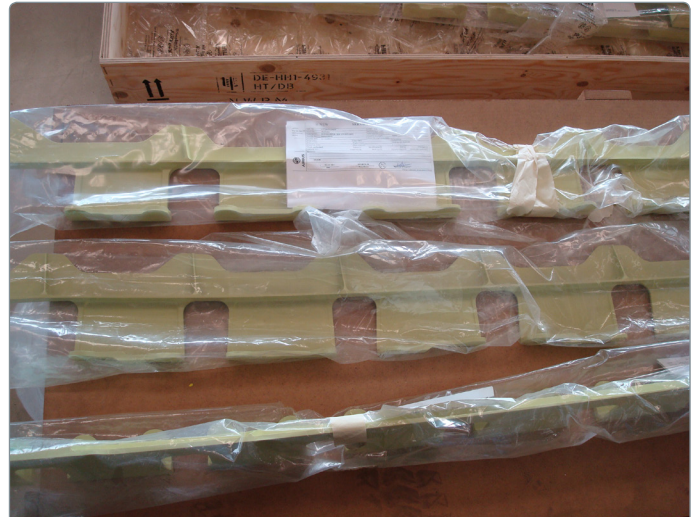
Picture 4 - Packaged rib feet booms on-site, for onward installation

For in-service aircraft, a program is already being worked out by Airbus that includes a permanent repair and long-term resolution of the issue with the Type 1 cracks. Replacement kits will be supplied and delivered by Airbus in accordance with the existing aircraft warranties.
